**TANNER LAKE DAM**

**RAY COUNTY, MISSOURI**

**MO. 11230**

**PHASE 1 INSPECTION REPORT  
NATIONAL DAM SAFETY PROGRAM**

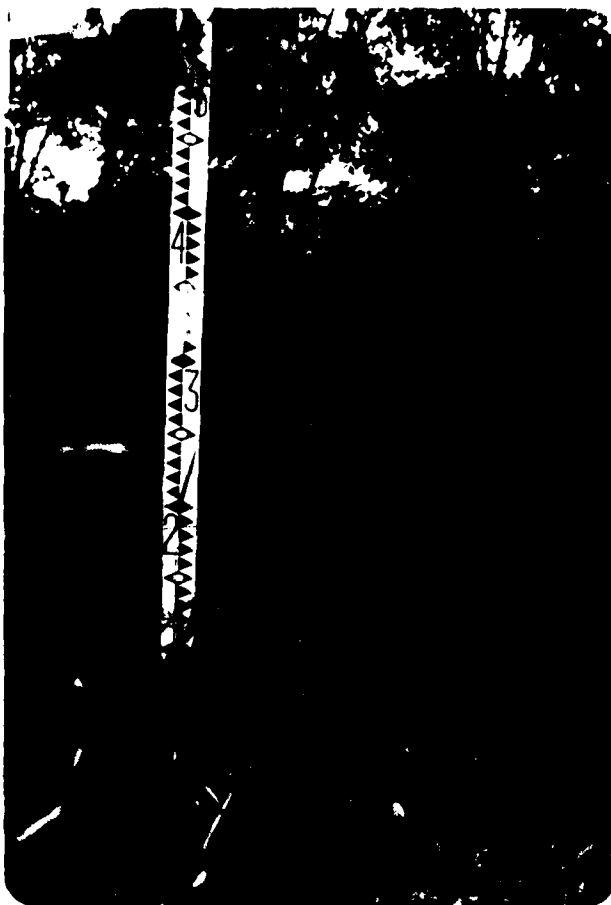
- (1) The principal spillway is uncontrolled. It consists of a 20-inch welded steel pipe with a hooded inlet and anti-vortex device. No signs of deterioration were noted in the inlet or outlet of the conduit. Measurements could not be taken to determine whether or not it was constructed according to plans. Photos No. 10, 11 and 12 show the inlet and outlet of the principal spillway. There was no flow through the spillway at the time of inspection. The reservoir level was about 2 feet + below the invert of the principal spillway at the time of inspection.
- (2) Emergency Spillway. According to the plans, the emergency spillway is cut through the right abutment. This area, shown in Photo No. 2, is so densely overgrown with locust trees and brush that it was not possible to recognize the spillway.
- (3) Drawdown Facilities. There are no drawdown facilities for this dam.

PHOTO NO. 10 - HOODED  
INLET TO THE PRINCIPAL  
SPILLWAY
